Periodic Inspection Report No. 4
West River
Townshend, Vermont

Townshend Lake

October 1996

US Army Corps
of Engineers

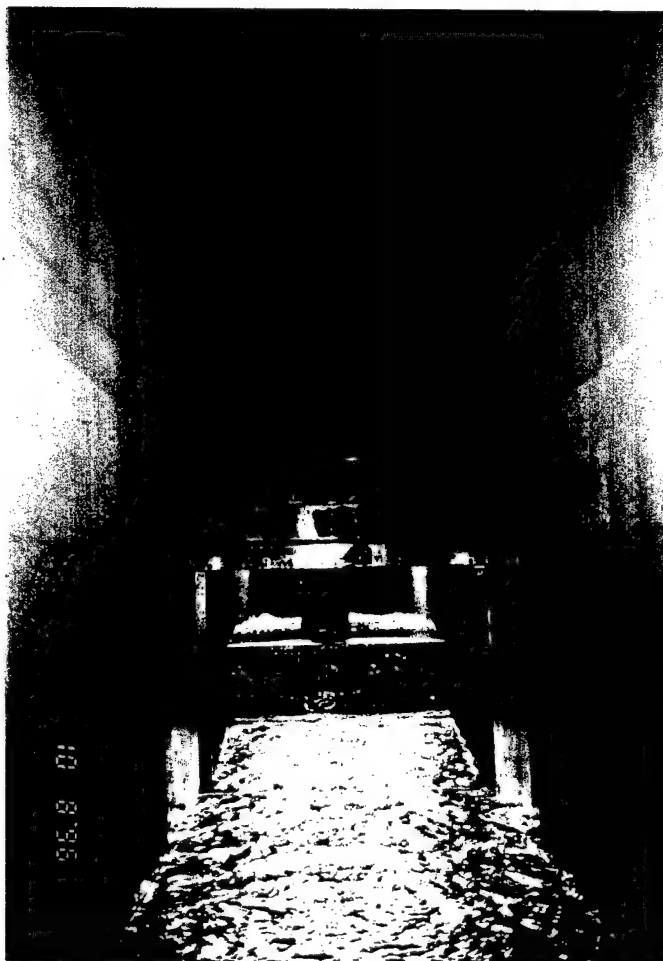
PHOTO A-12. Downstream face of service gate No. 2.

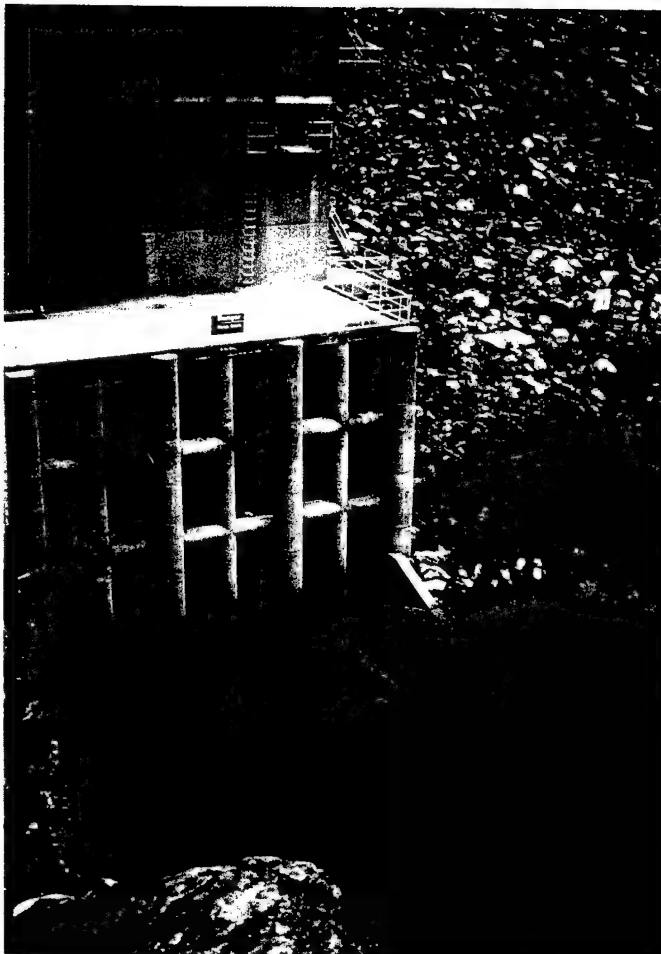
PHOTO A-14. General
view of upstream
control weir and trash
rack.

Modify upcoming contract to build the fish passage facility to include repair of the concrete erosion at the base of the trash rack in front of gate 2. Completed during FY92.

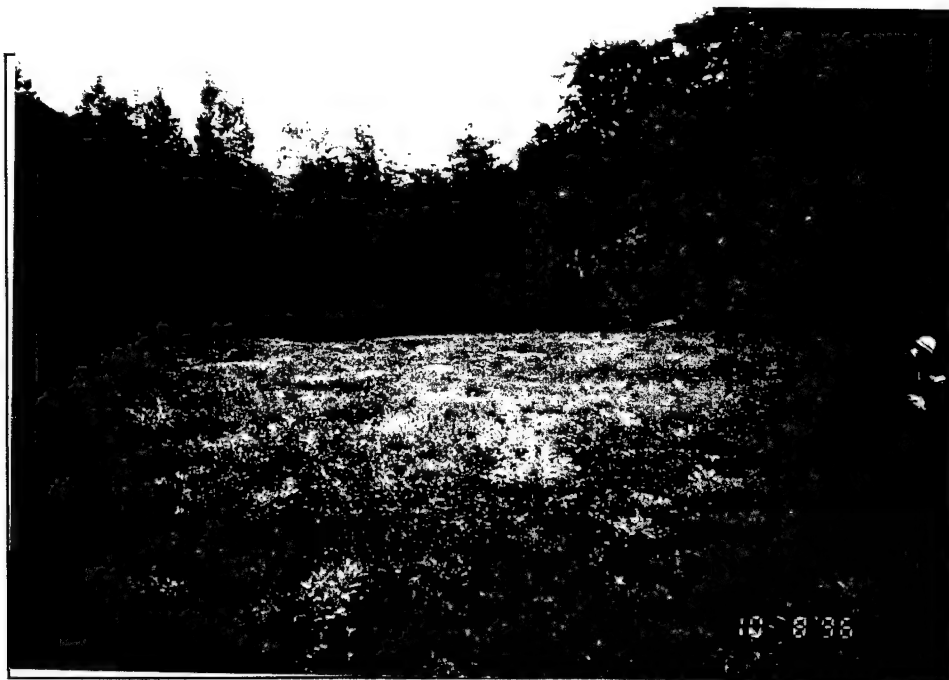
Photo D-1 Spillway approach looking upstream

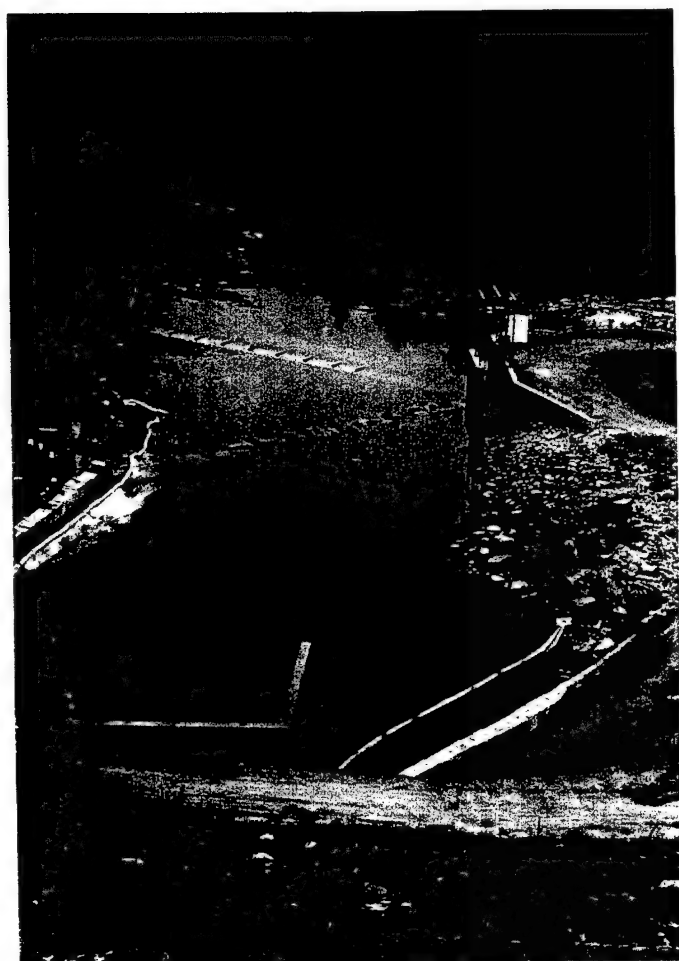
Photo D-4 Exit channel looking downstream

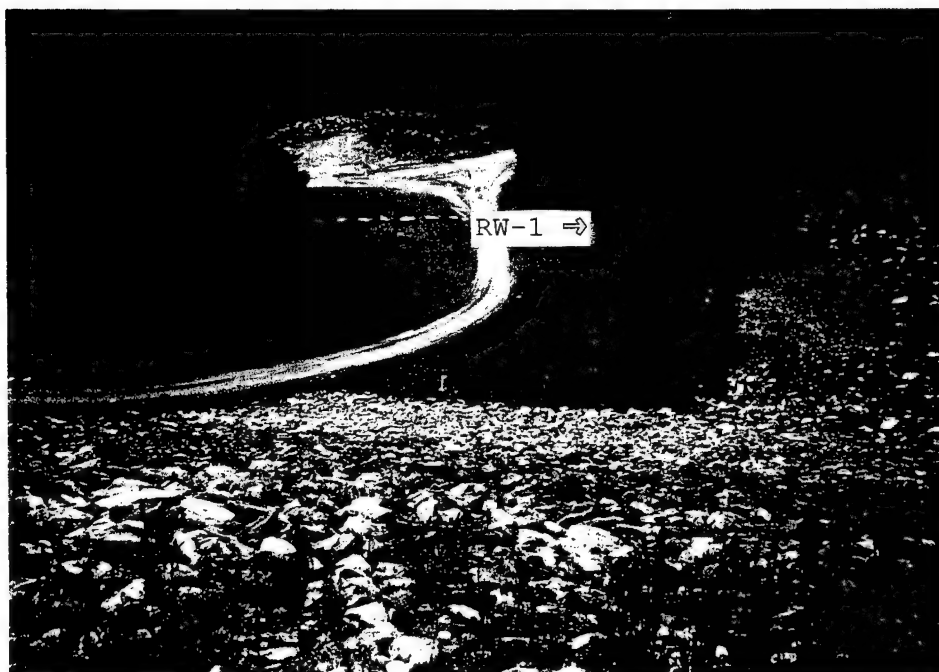
PHOTO E-2: View of relief wells at downstream toe of dam. Note large trees near relief well at upper right of picture.

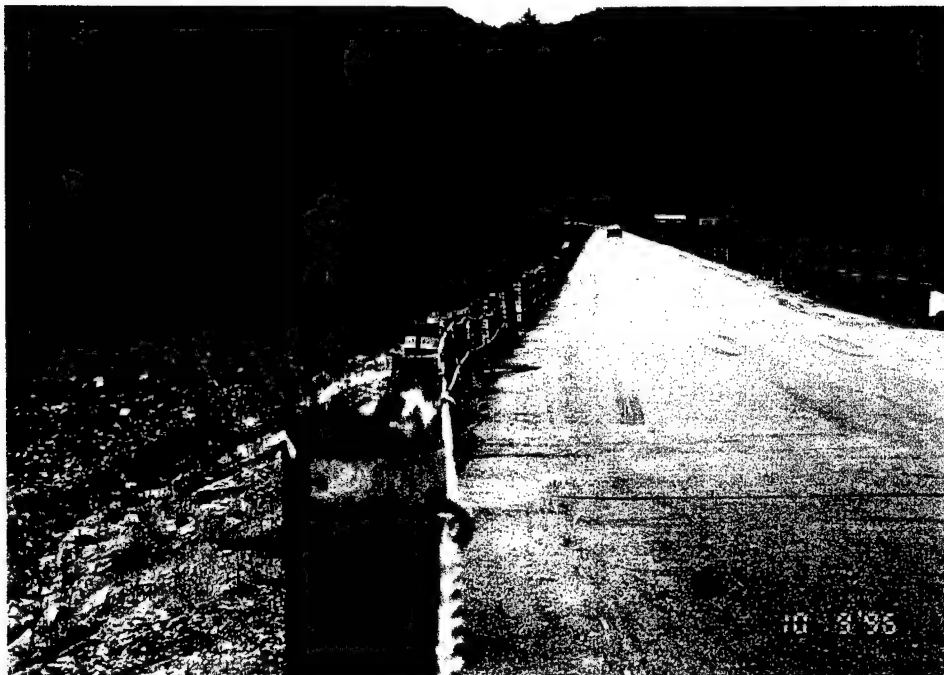
PHOTO E-3: Crest of dam, looking towards right abutment. Note posts moved out of alignment by snow plows.

(a) Vertical Movement. As shown on Plate 3, the surveys indicate that the largest vertical movement of any one crest monument from 1978 to 1996 was 0.37 ft (4.43 in), measured at monument T-11. This movement is attributed to the monument having sustained physical damage from snow plowing prior to the 1996 survey. Excluding monument T-11, the largest settlement was 0.13 ft (1.56 in), which occurred at monument T-6. Monuments T-3 through T-6, all located above the old river valley where the embankment has its greatest height,

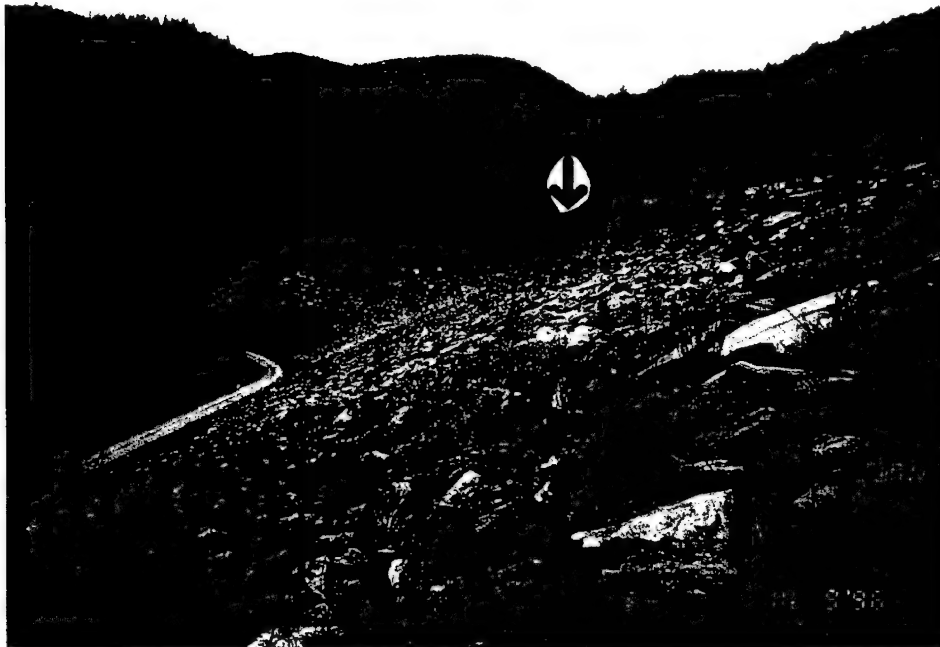
PHOTO E-7: General view of downstream slope of dam.
Note tree growth at top of rock fill blanket (at
arrow).

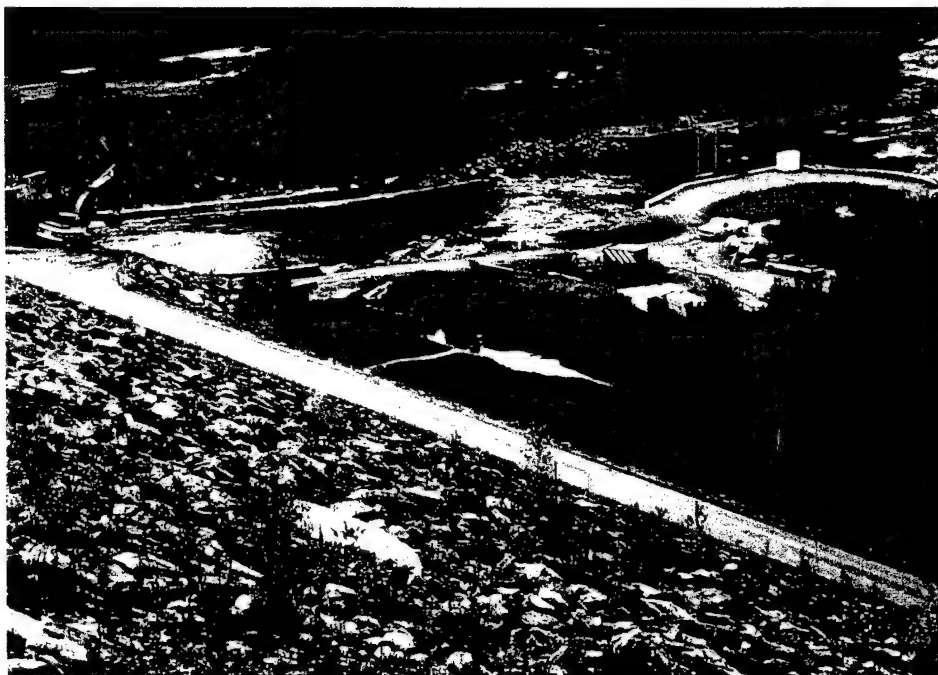
PHOTO E-10: View of seepage pool and outlet channel. Note seepage at downstream toe.

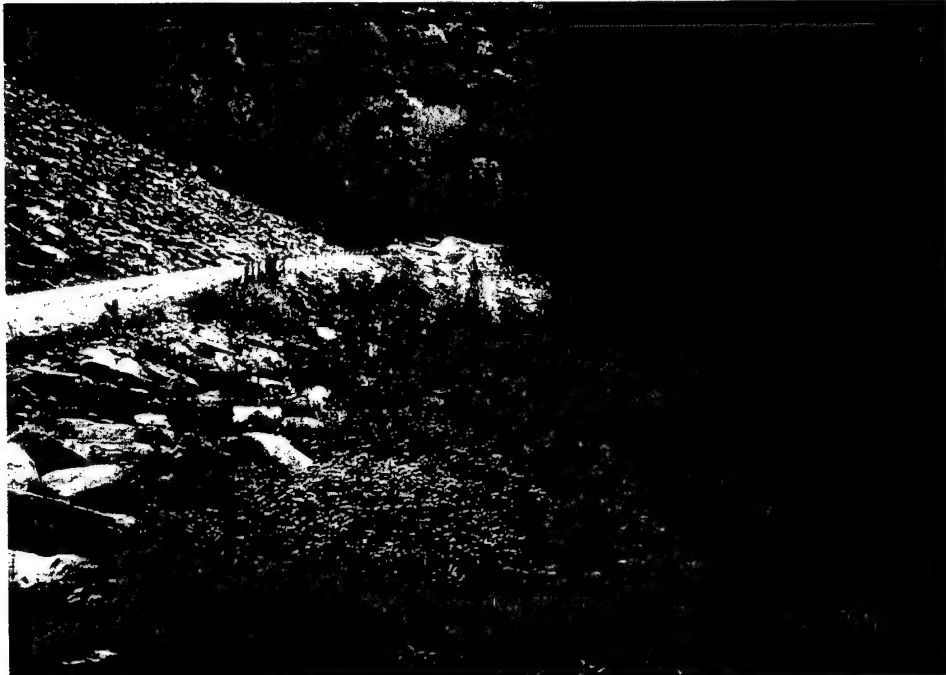
PHOTO E-11: View of relief well outlet channel.
Note heavy brush growth within channel.

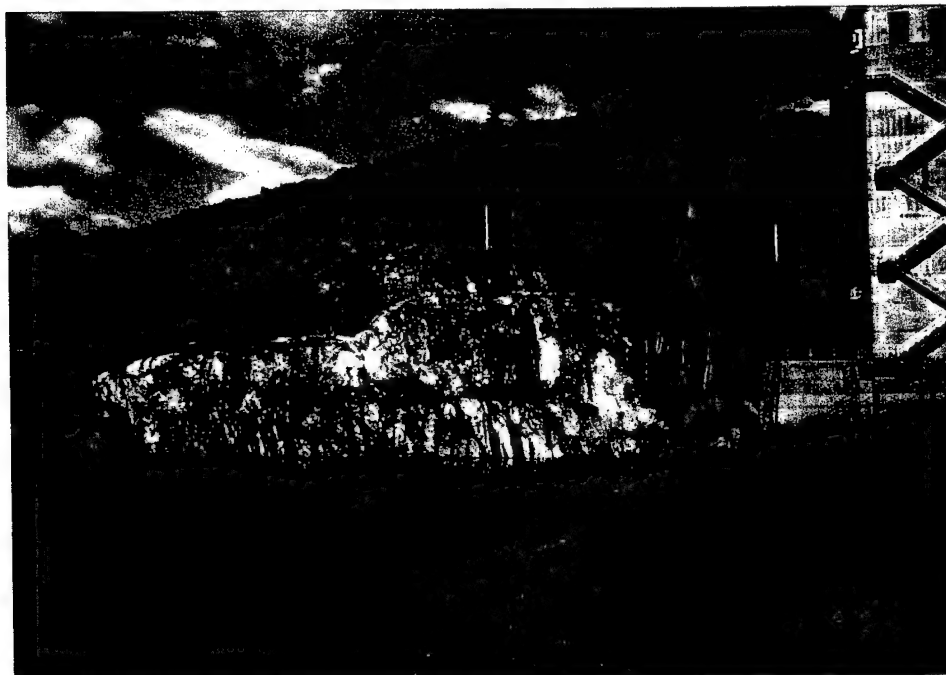
PHOTO E-12: Rock face at intake channel. Note
impervious blanket in foreground.

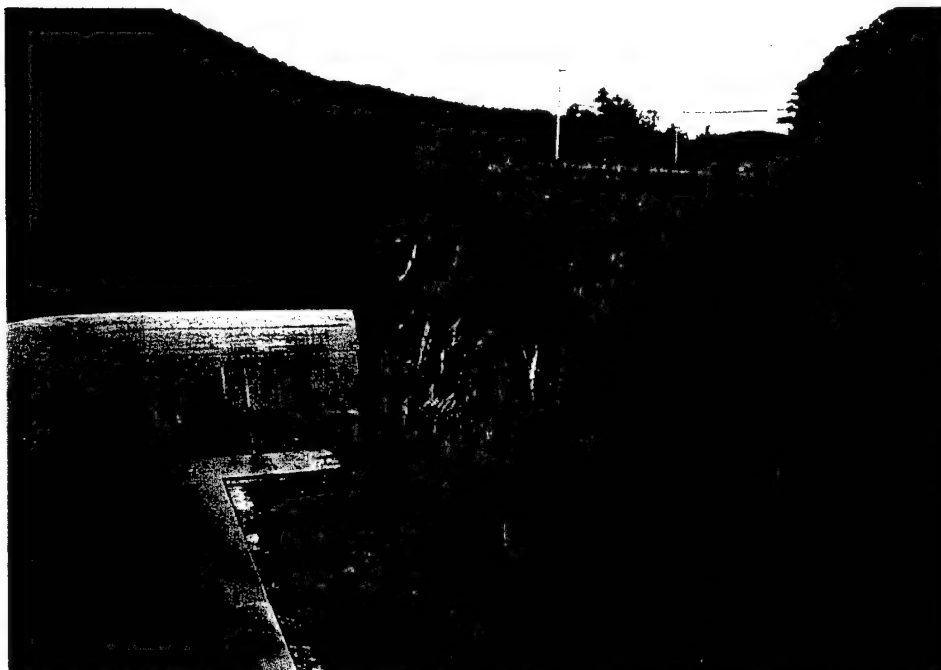
PHOTO E-14: Spillway weir, with view of approach and discharge channels.

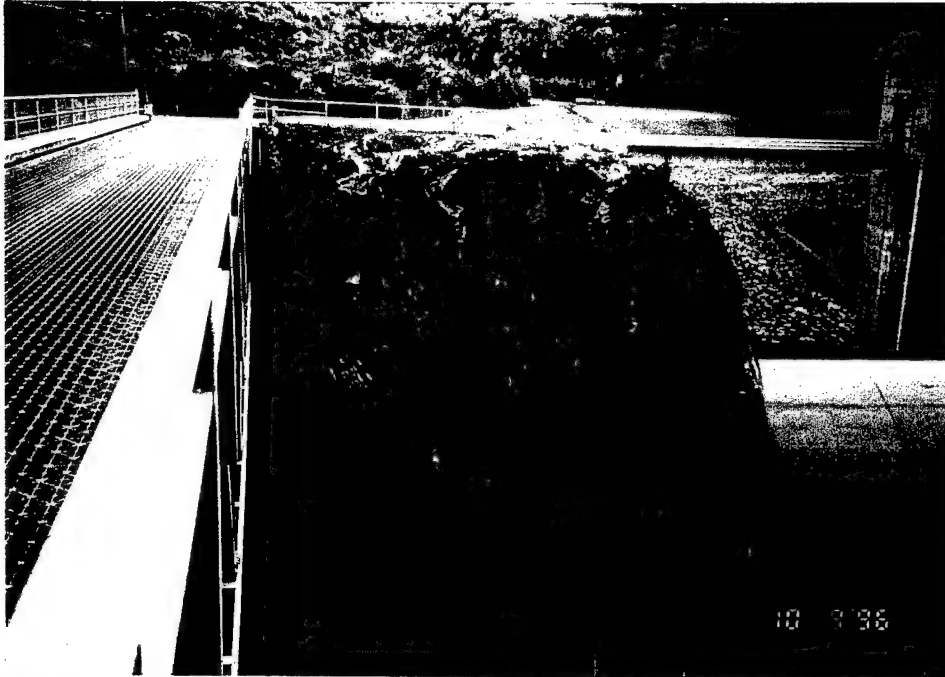
PHOTO E-17: Exposed rock face at spillway bridge
right abutment.
